BULGA COAL COMPLEX

Annual Environmental
Management Report 2009

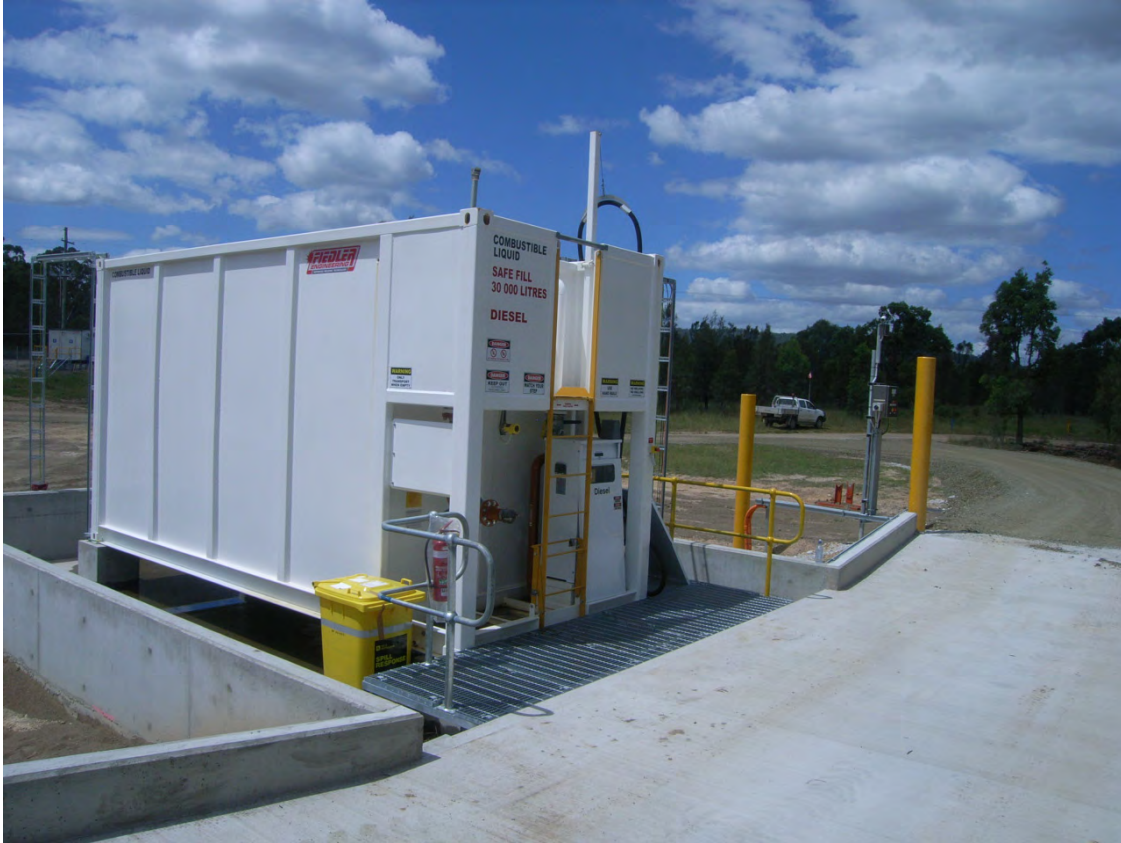
Plate 2-1 The gas drainage hydrocarbon storage facility constructed during the reporting period

The Gas Drainage Hydrocarbon Storage Facility constructed during the reporting period is located at the Gas Drainage Contractors Laydown Area, about 400m south of the Beltana Methane Flaring Facility. The location of the recently constructed hydrocarbon storage facility is shown in **Figure 2-1**.

This facility allows gas drainage contractors to refuel vehicles and machinery in a safe and environmentally responsible manner, minimising the need for portable fuel storages. **Plate 2-1** illustrates the completed hydrocarbon storage facility. This facility is temporary while drilling is undertaken for gas drainage in the Blakefield seam.

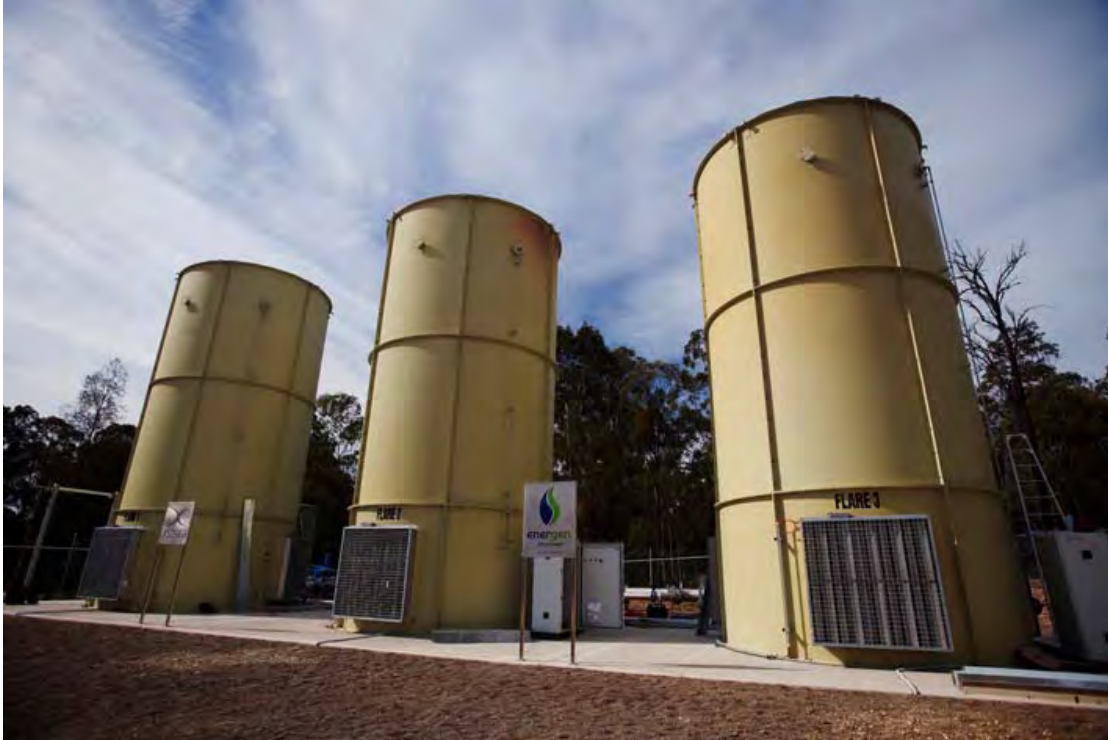
Plate 2-2 The new Energen methane flaring facility installed at the Underground Operations during 2009

The 3 new Energen methane flares (shown in **Plate 2-2**) add additional flaring capacity to the 5 existing LMS flares at the Underground Operations.

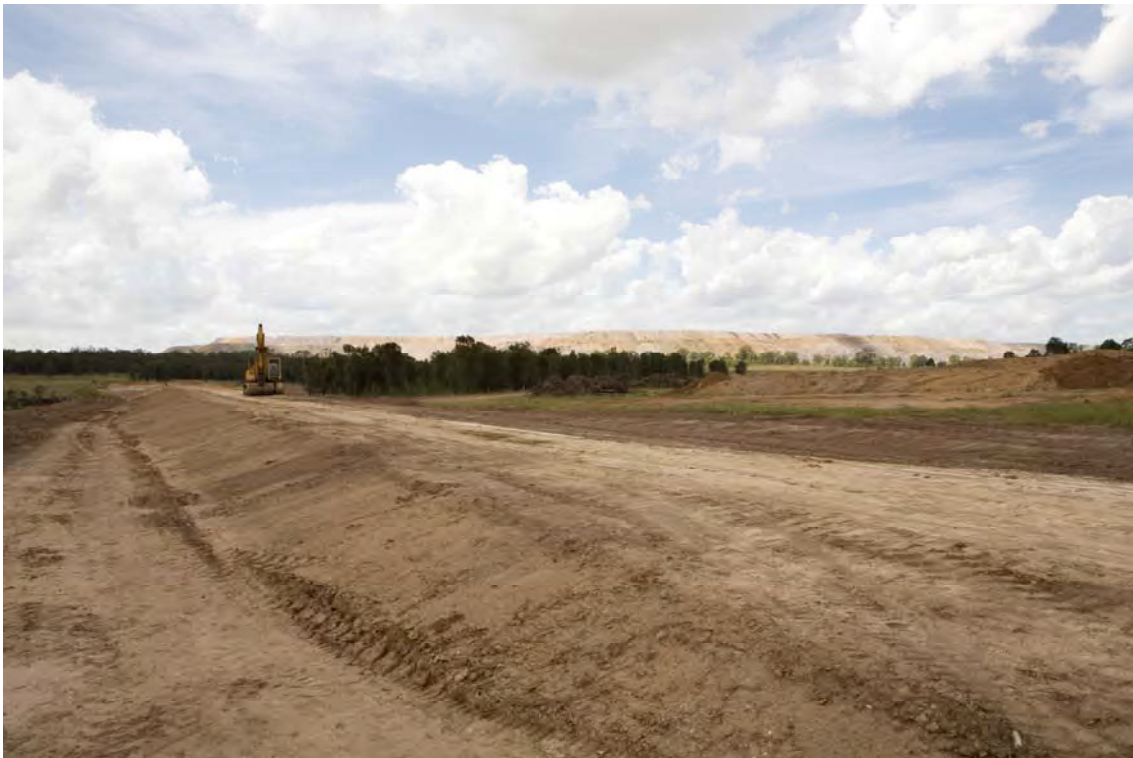
Plate 2-3 The Wollombi Brook Flood Levee as commenced in December 2009

Construction of the Wollombi Brook Flood Levee was started in 2009 across the Northern Drainage Line in the area immediately east of Beltana Longwall 14. The location is illustrated in **Figure 2-1**.

Construction of the levee is a requirement of the Underground Operations Development Consent (DA 376-8-2003). The Bulga Coal Continued Underground Operations EIS (2003) recommended a flood levee be constructed to minimise the risk of surface water ingress into the Beltana underground workings during a flood event, specifically Whybrow Longwalls 13 and 14.

- a) Remain stable under a 1 in a 100 year ARI flood event.
- b) Not cause an increase in backwater stream heights in Wollombi Brook of greater than 20 mm upstream of the confluence of the unnamed watercourse and Wollombi Brook under conditions up to and including a 1 in a 100 year ARI event.

The unnamed watercourse in this instance is the watercourse internally referred to as the Northern Drainage Line. The Wollombi Brook Flood Levee has been constructed in accordance with these criteria. **Plate 2-3** illustrates the Wollombi Brook Flood Levee, under construction in late 2009. The exposed levee banks will be rehabilitated with pasture seed early in 2010.

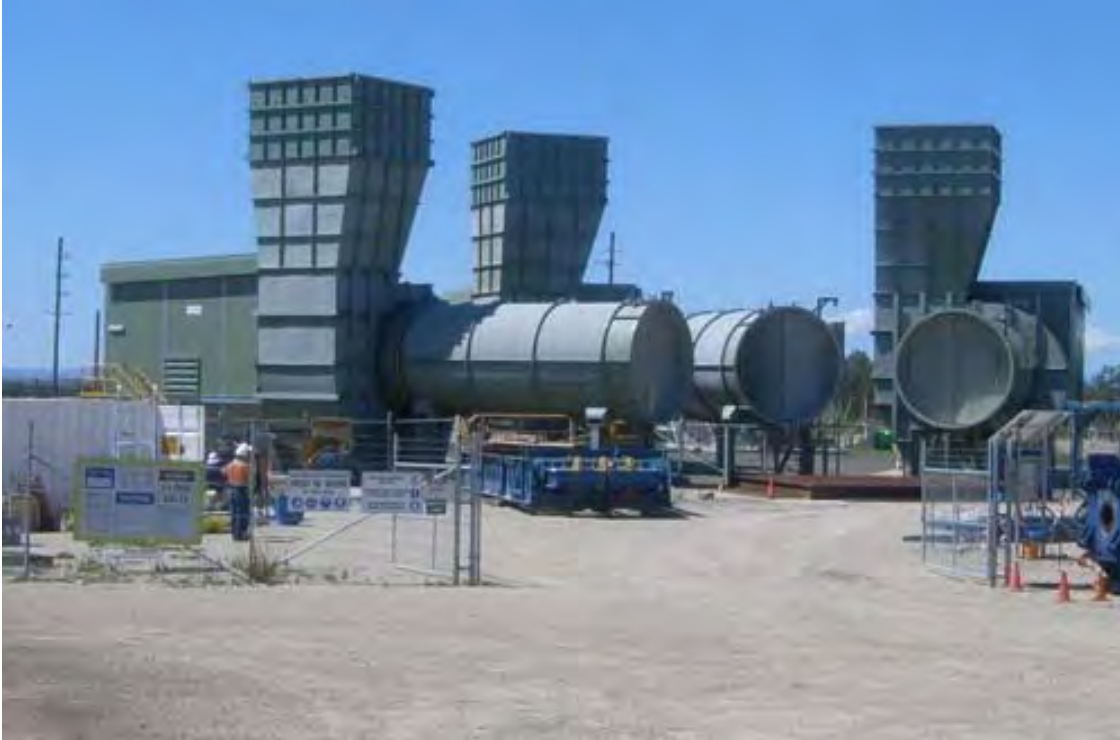
Plate 2-4 Blakefield South No 2 ventilation fans under construction

The Blakefield South No 2 Ventilation Shaft and Fans will provide ventilation during the extraction of the Blakefield South Longwalls in the Blakefield Seam. The partially constructed ventilation fans are illustrated in **Plate 2-4** below.

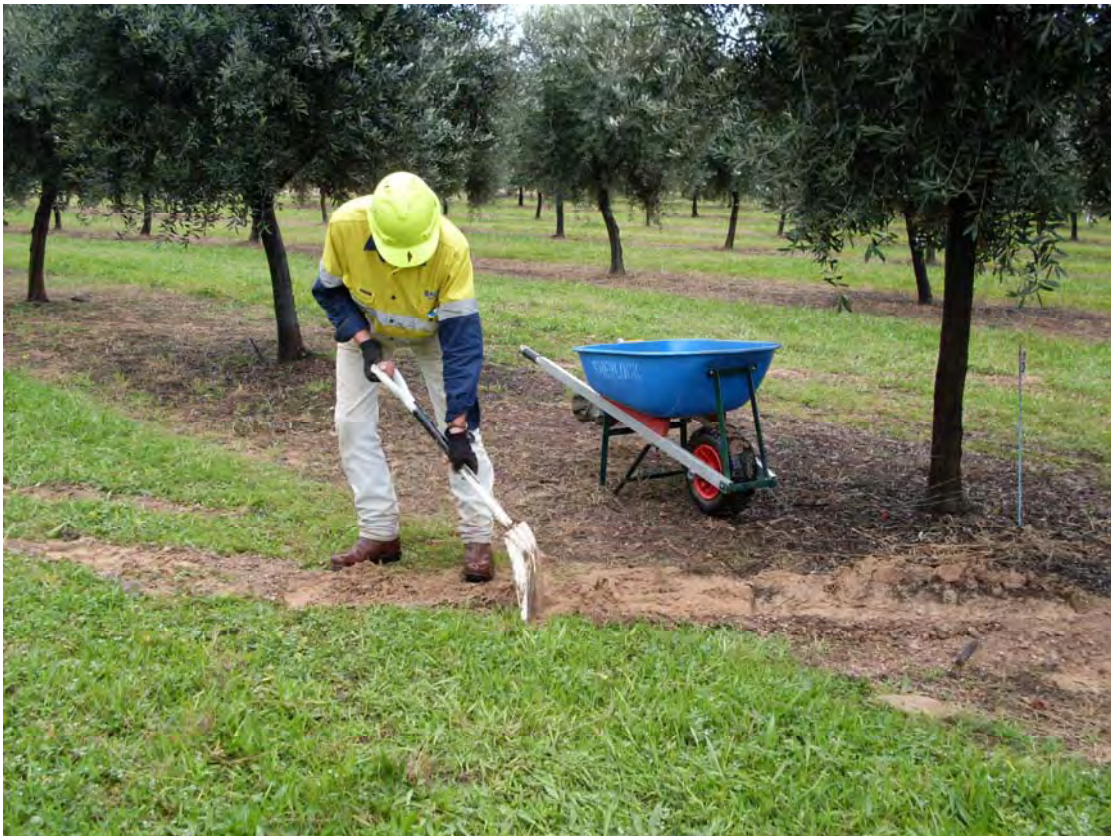
Plate 2-5 Subsidence repairs using wheelbarrow and shovel in the 'Atulya' olive grove over Longwall 11

The minimal disturbance method of repairing the subsidence cracks used during 2008 continued to be implemented in 2009. This method involved clay filling and topsoil coating each crack by wheelbarrow and shovel, or rolling small cracks with a 12 tonne vibrating sheep's-foot roller. **Plate 2-5** provides an example of manual subsidence repairs over Longwall 11. **Plate 2-6** provides an example of subsidence repairs using a vibrating sheep's-foot roller over Longwall 11.

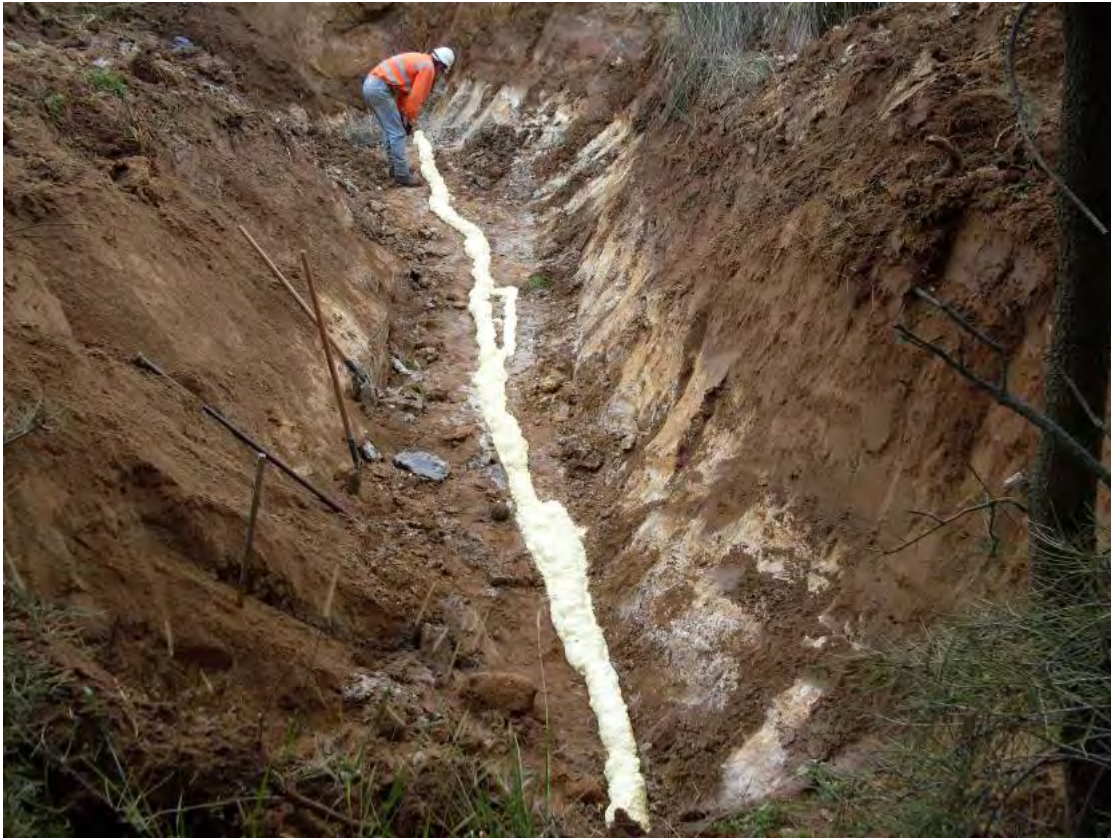
Plate 2-7 Polyurethane resin being used to seal cracking in sandstone along the Northern Drainage Line

A new subsidence repair method was trialled in 2009 to repair rock fractures along the Northern Drainage Line.

Cracks in sub-surface rock were excavated until the surface of the cracked rock was accessible for repair. The cracked rock was then injected with polyurethane resin (PUR) foam. Clay was then used to fill the excavated area and compacted. A 10-20cm layer of topsoil was finally placed over the clay.

This method of repair proved successful in areas where water-sealing of cracks was necessary to minimize gully erosion and surface water loss into the underlying subsided strata. An example of repairing fractured rock in the Northern Drainage Line using the PUR foam injection method is provided in **Plate 2-7** below.

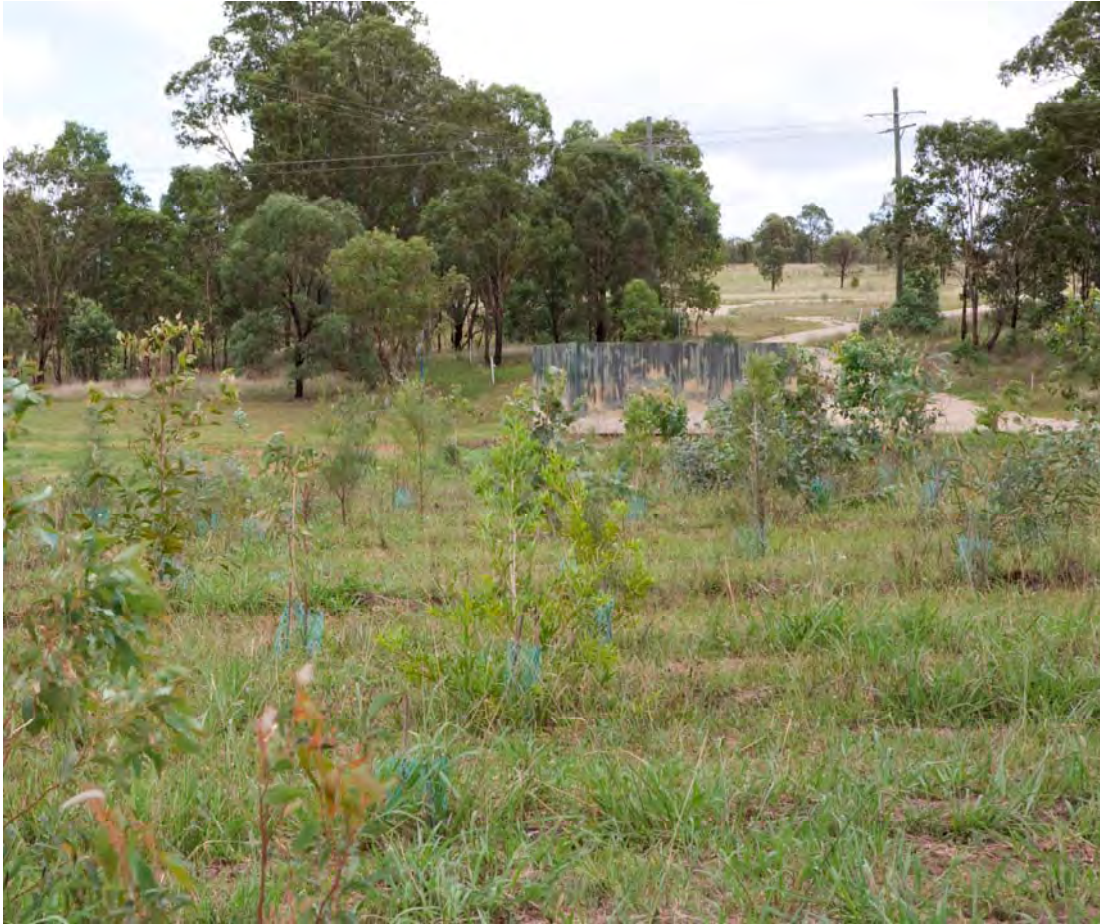
Plate 2-8 Tubestock planting providing visual screening around a vertical gas well near the intersection of Broke Road and Charlton Road

As outlined in **Section 2.2.1**, all gas well sites are rehabilitated as construction works are completed. The seed mix provided in **Table 2-8** is used in the rehabilitation of the gas well sites, and other disturbed sites. Tubestock planting has also been used in areas where rapid establishment of visual screening is required. An example of visual screening of gas wells using tubestock planting is provided in **Plate 2-8**.

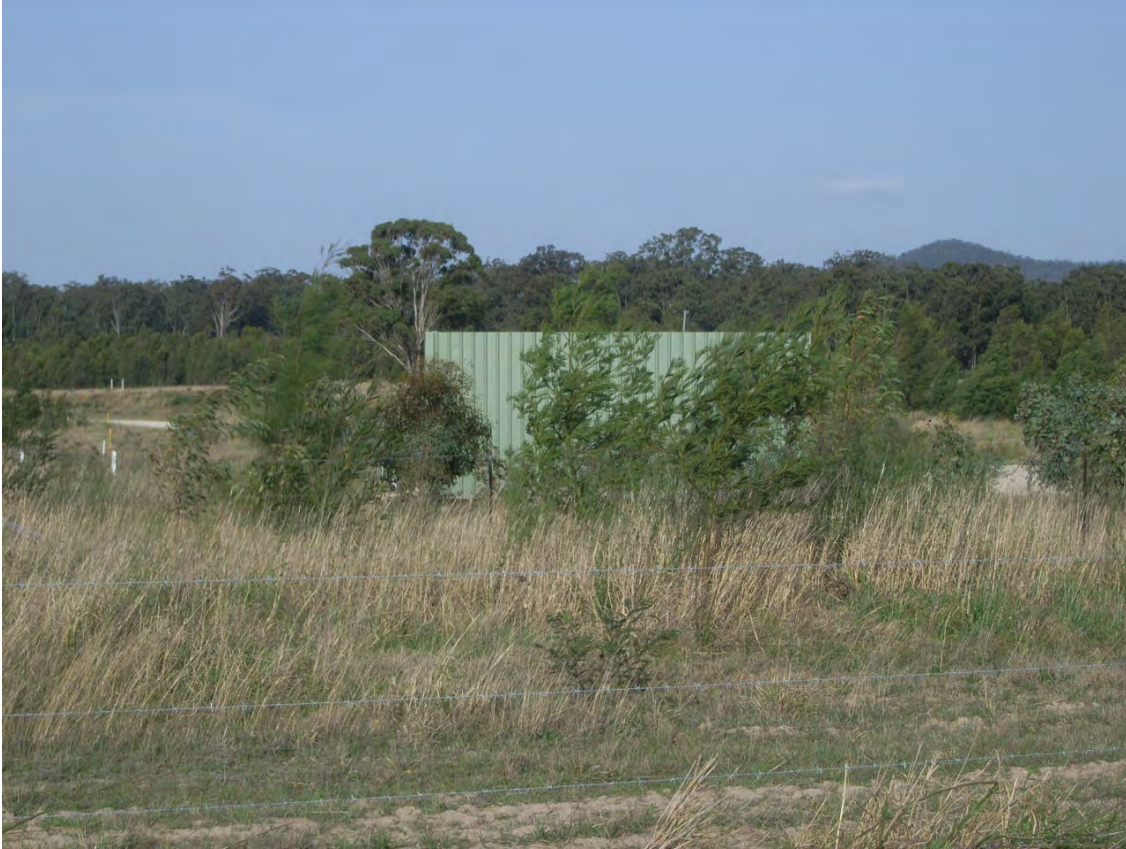
Plate 2-9 Established vegetation providing visual screening around gas wells

Native tubestock and tree seed planted during 2007 and 2008 has now become well established around many of the gas wells and is providing effective visual screening. **Plate 2-9** shows an example of the establishment of visual screening vegetation around a vertical gas well adjacent to Charlton Road.

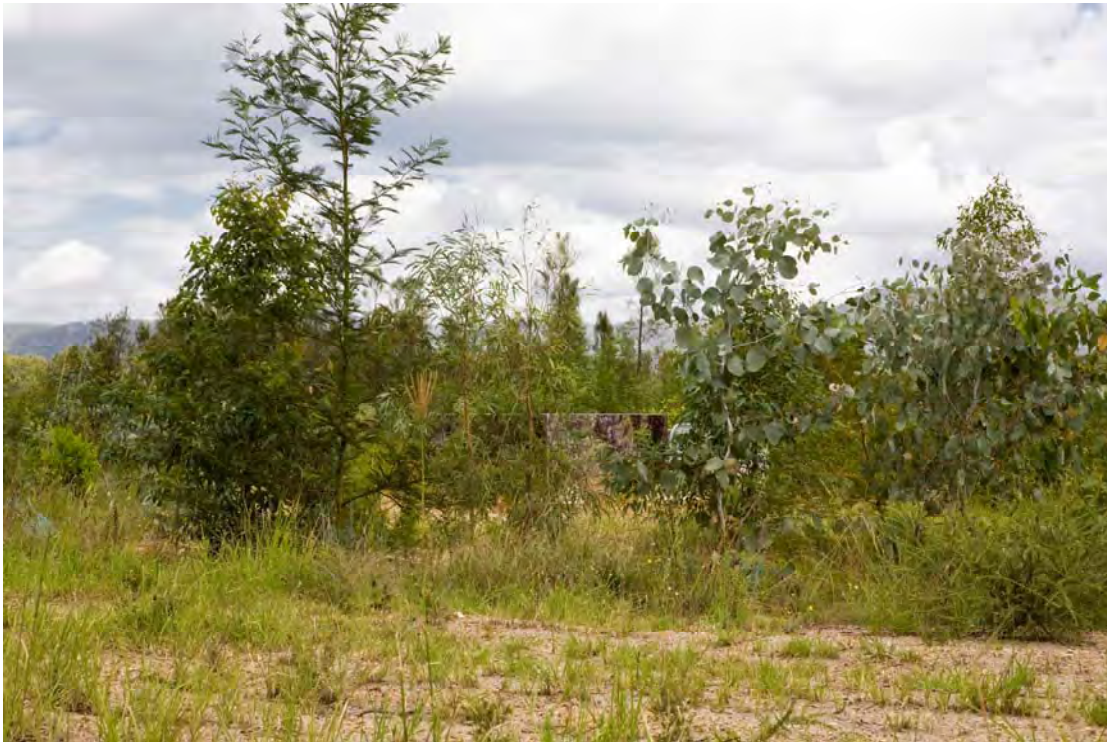
Plate 2-10 Photo decal and vegetation visual screening of a SIS gas well, viewed from the edge of Broke Road

Surface to in-seam gas wells that are covered by decals of surrounding vegetation are now barely visible behind the well established native tree seed as shown in **Plate 2-10**.

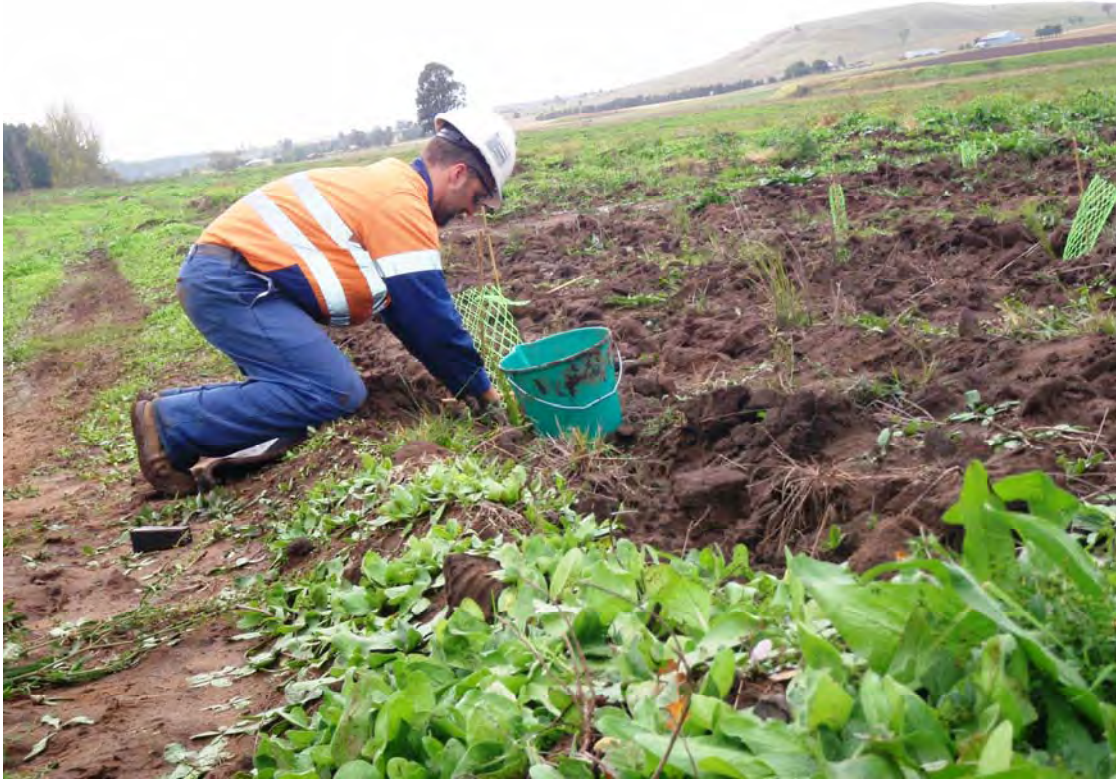
The River Red Gum Ecological Community Restoration Project aims to re-establish the endangered River Red Gum Ecological Community on mine owned land. River Red Gum seed was source from the few remaining trees in the Broke area and propagated into tube stock. The first stage of this project involved planting 8.9Ha of mine owned alluvial flats adjacent to the Wollombi Brook. The plan agreed upon after consultation with ecologists and rehabilitation consultants is shown below in **Figure 2-4**. Over 2000 plants were hand-planted, of which 600 were River Red Gums. **Plate 2-11** demonstrates the manual planting in progress. To date the survival rate of this first stage has been over 95%. The second stage of this restoration project is planned for mid-2010, and will involve the establishment of another 3Ha of River Red Gum Ecological Community to the north as illustrated on **Figure 2-5**.

Plate 2-11 The river red gum ecological community restoration project

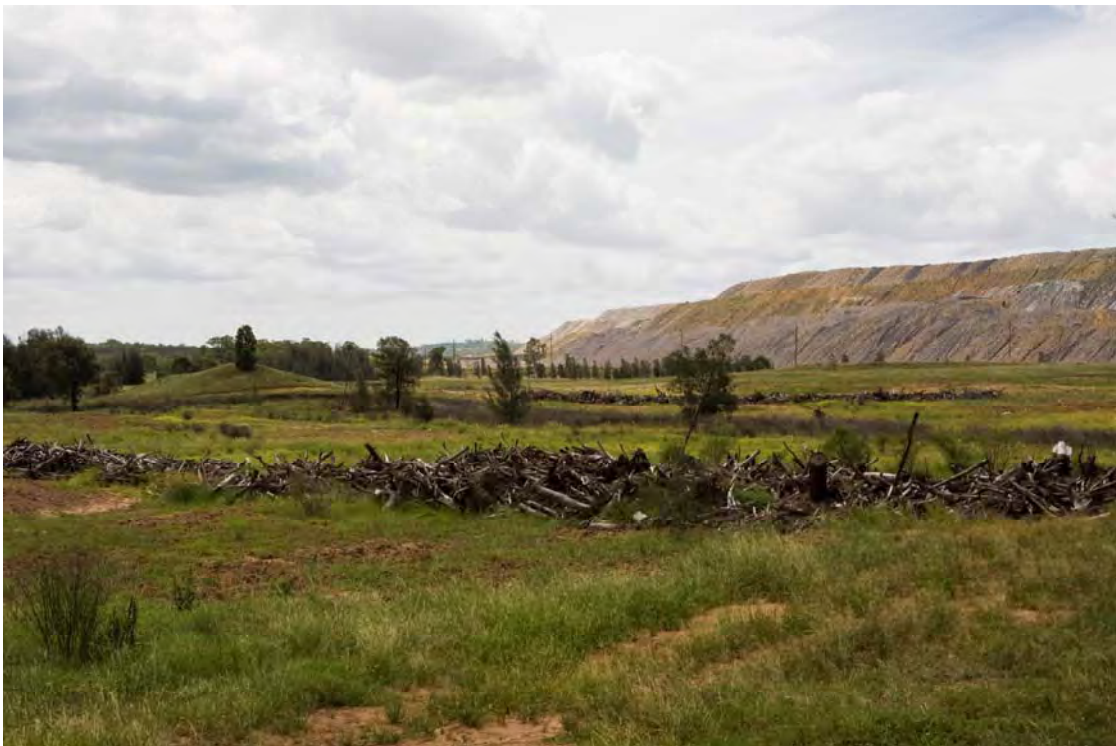
The Northern Drainage Line Rehabilitation Project aimed to stabilise a section of the Northern Drainage Line that had poor vegetative cover, and in doing so, to also extend the vegetation growing along the drainage in the north-west region of the mine lease area. The project involved tubestock planting, seeding, and erosion control structures to maintain soil stability and promote vegetation establishment. Stands of timber were intentionally placed throughout the area to provide habitat and act as sediment traps. **Plates 2-12, 2-13 and 2-14** illustrate area of the tubestock planting and timber stands installed as part of the Northern Drainage Line Restoration Project.

Plate 2-12 Rehabilitation works on the Northern Drainage Line over Longwall 9 following December rainfall

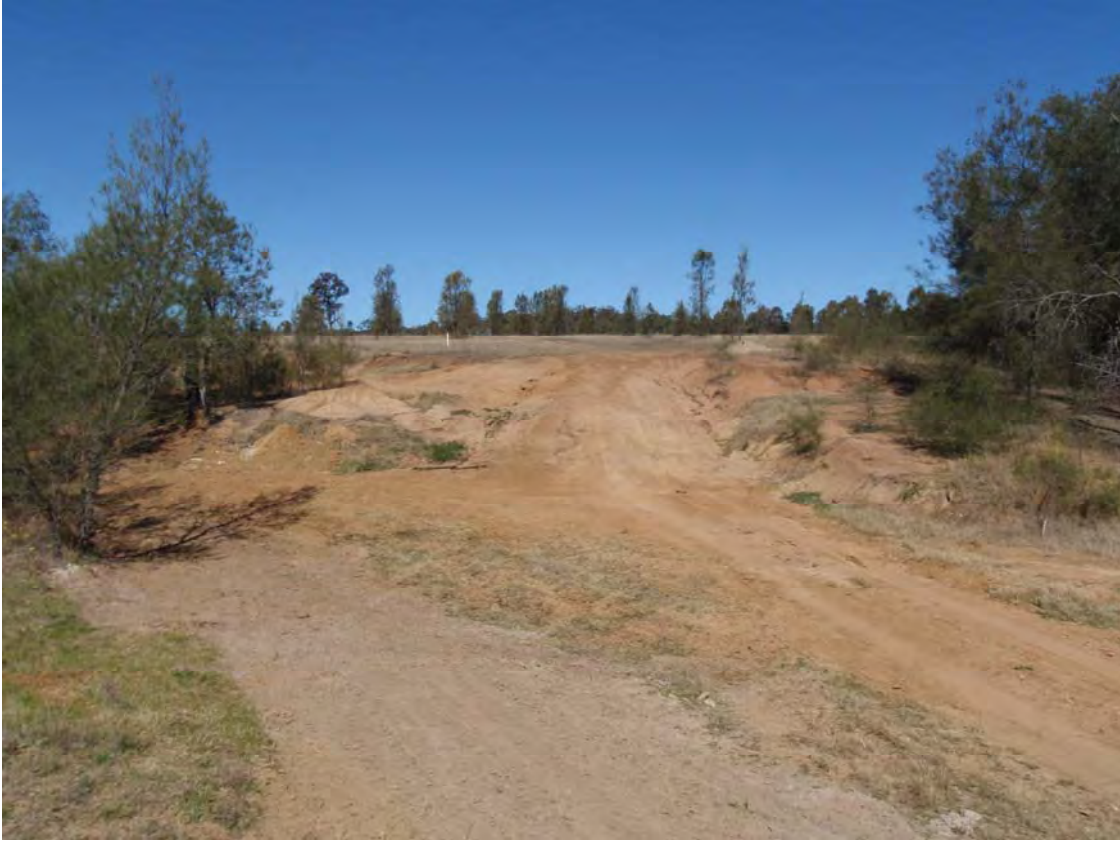
Plate 2-13 A bare eroded slope along the Northern Drainage Line prior to rehabilitation

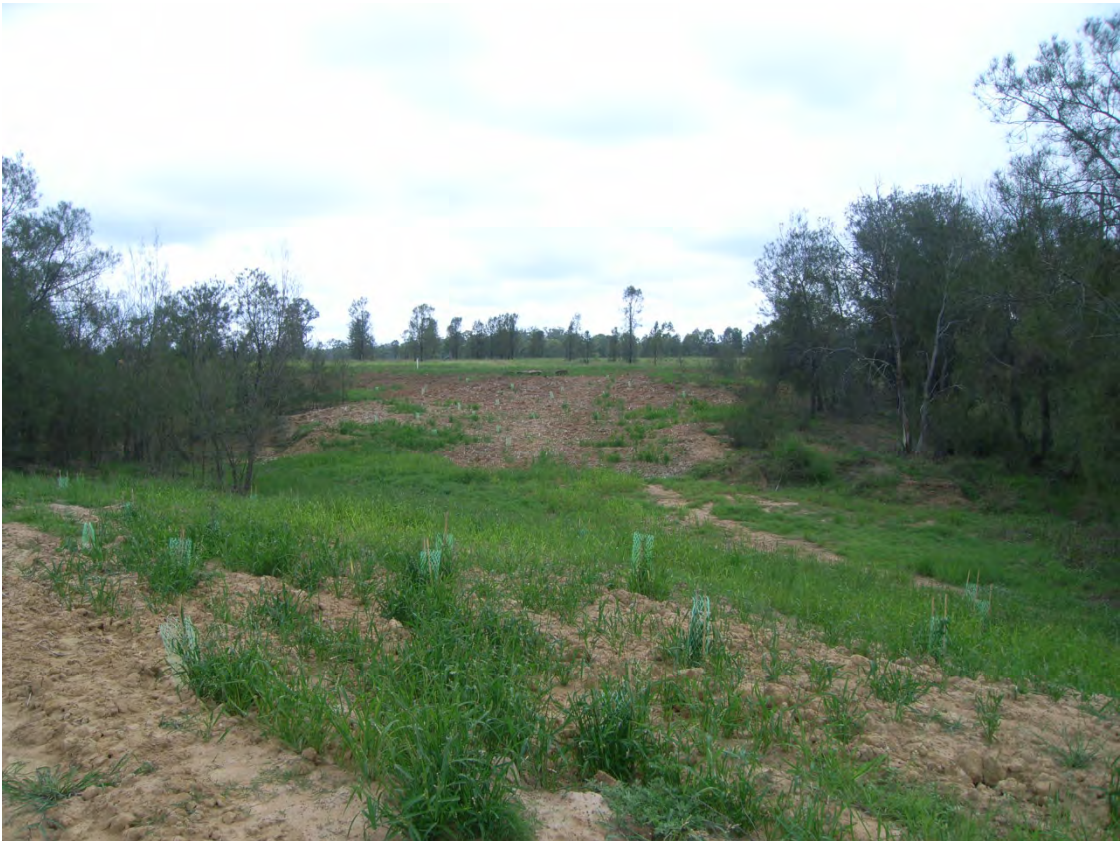
Plate 2-14 The same slope along the Northern Drainage Line 3 months after rehabilitation

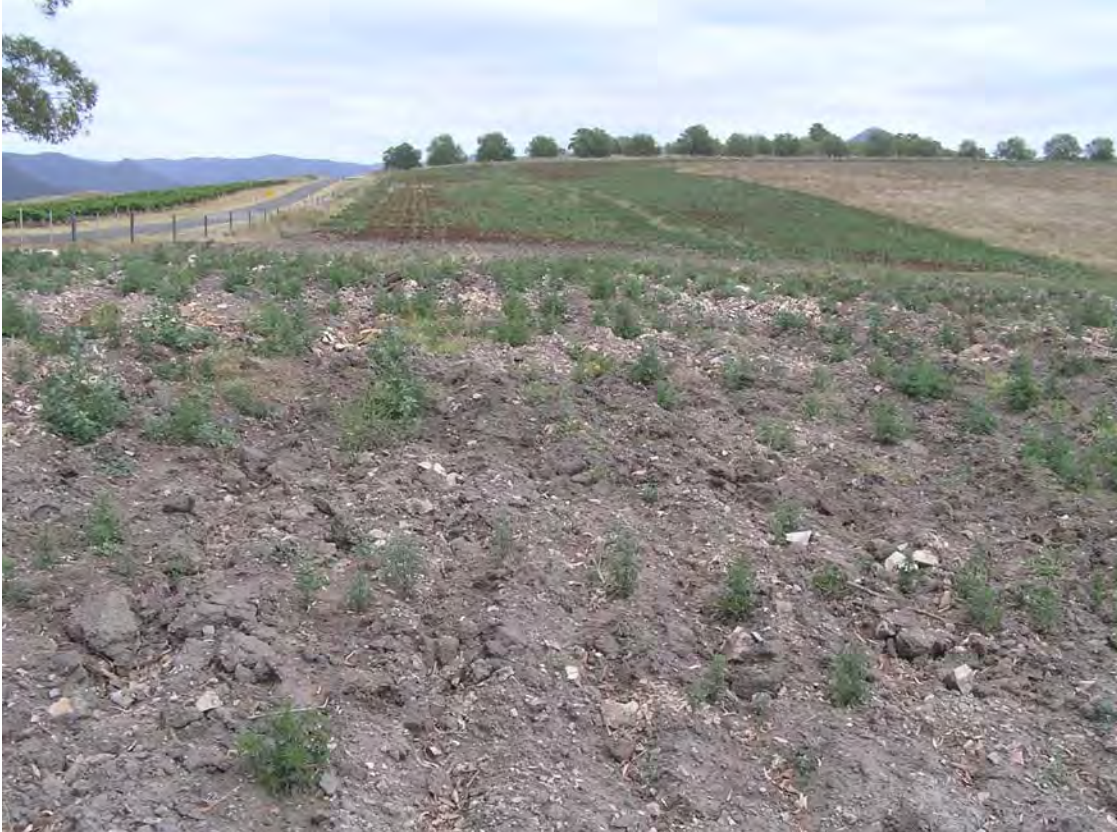
Additional revegetation works were undertaken during 2009 over an area of 3.8Ha on mine owned land adjacent to Cobcroft Rd. This area was ripped and seeded with native tree species. **Plate 2-15** provides an example of the ripped and seeded area. The works were undertaken in an area adjacent to remnant woodland to aid in the development of vegetation corridors. The extent of the Cobcroft Rd revegetation works are illustrated in **Figure 2-1**.

Plate 2-15 Direct tree seeding in a paddock adjacent to Cobcroft Road

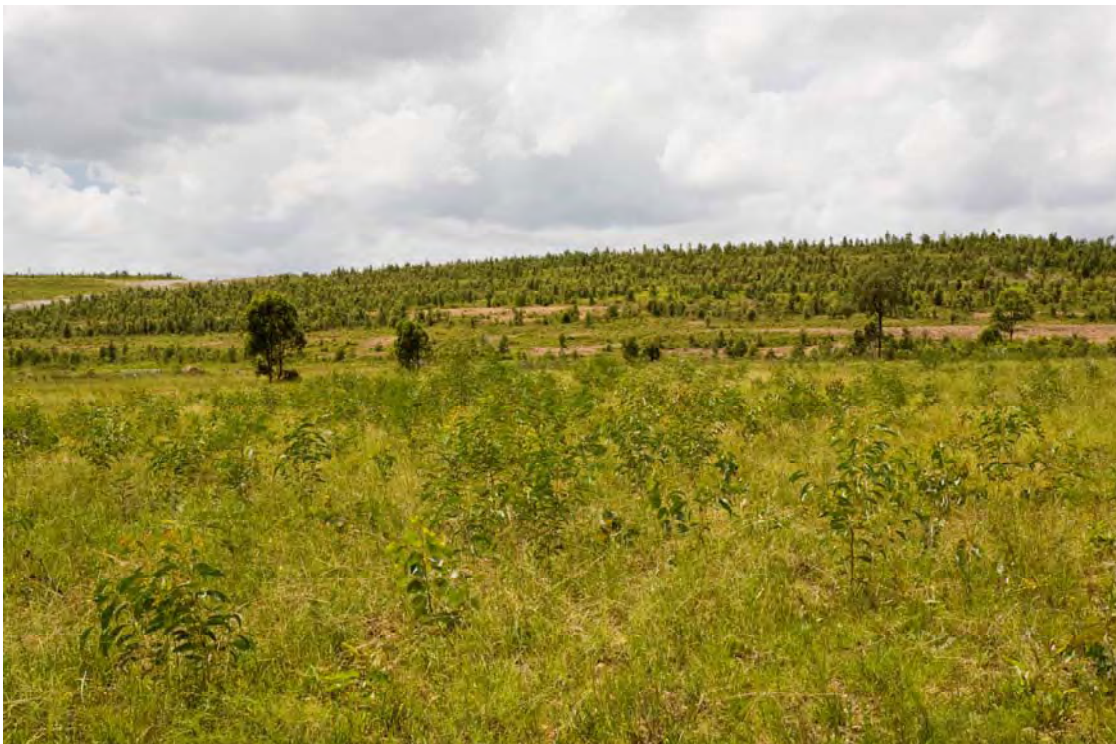
- Favourable conditions allowed the direct seeding and tubestock planting undertaken in previous years to undergo significant growth and become well established. An example of this is the old air strip rehabilitation site, which has become well established with a thick cover of native trees (See **Plate 2-16** below).

Plate 2-16 Rehabilitation works over the old airstrip (with the Southern Extension Waste dump in the distance)

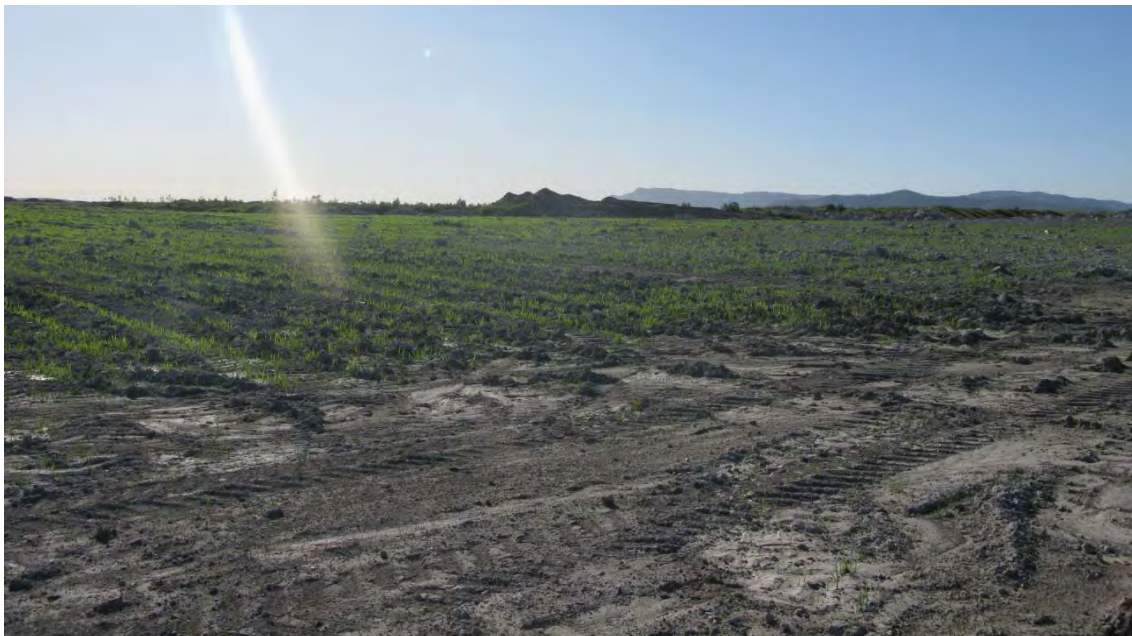
Plate 3-1 **Early strike - Whybrow Spoils facing south**

Plate 3-1 and **Plate 3-2** show some of the rehabilitation activities at the Open Cut Operation site and an example of a rehabilitated area.

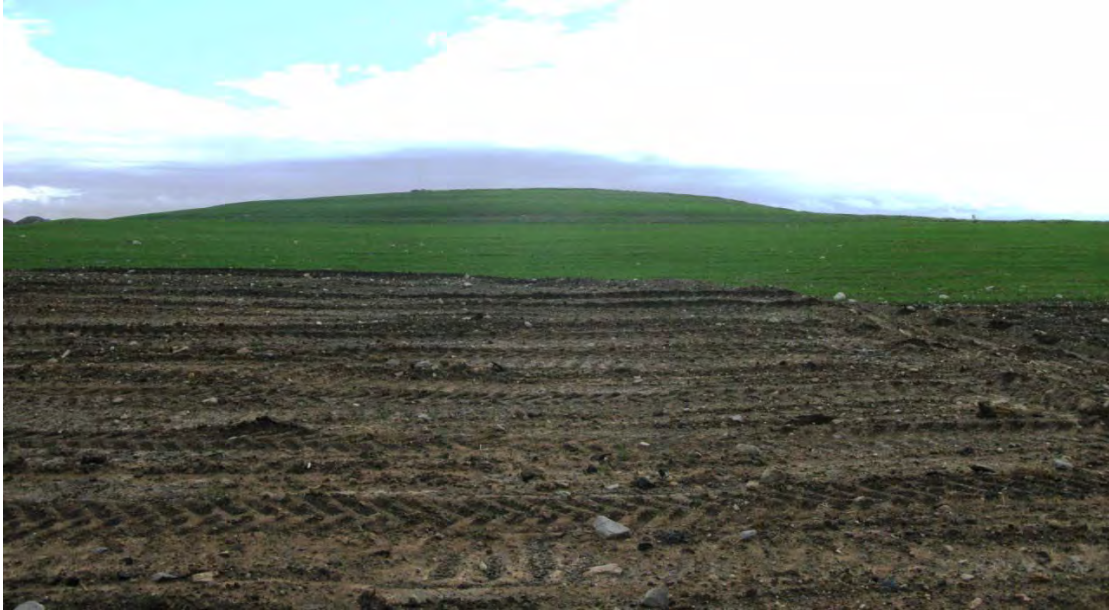
Plate 3-2 Perspective unshaped dump facing north to germinated area

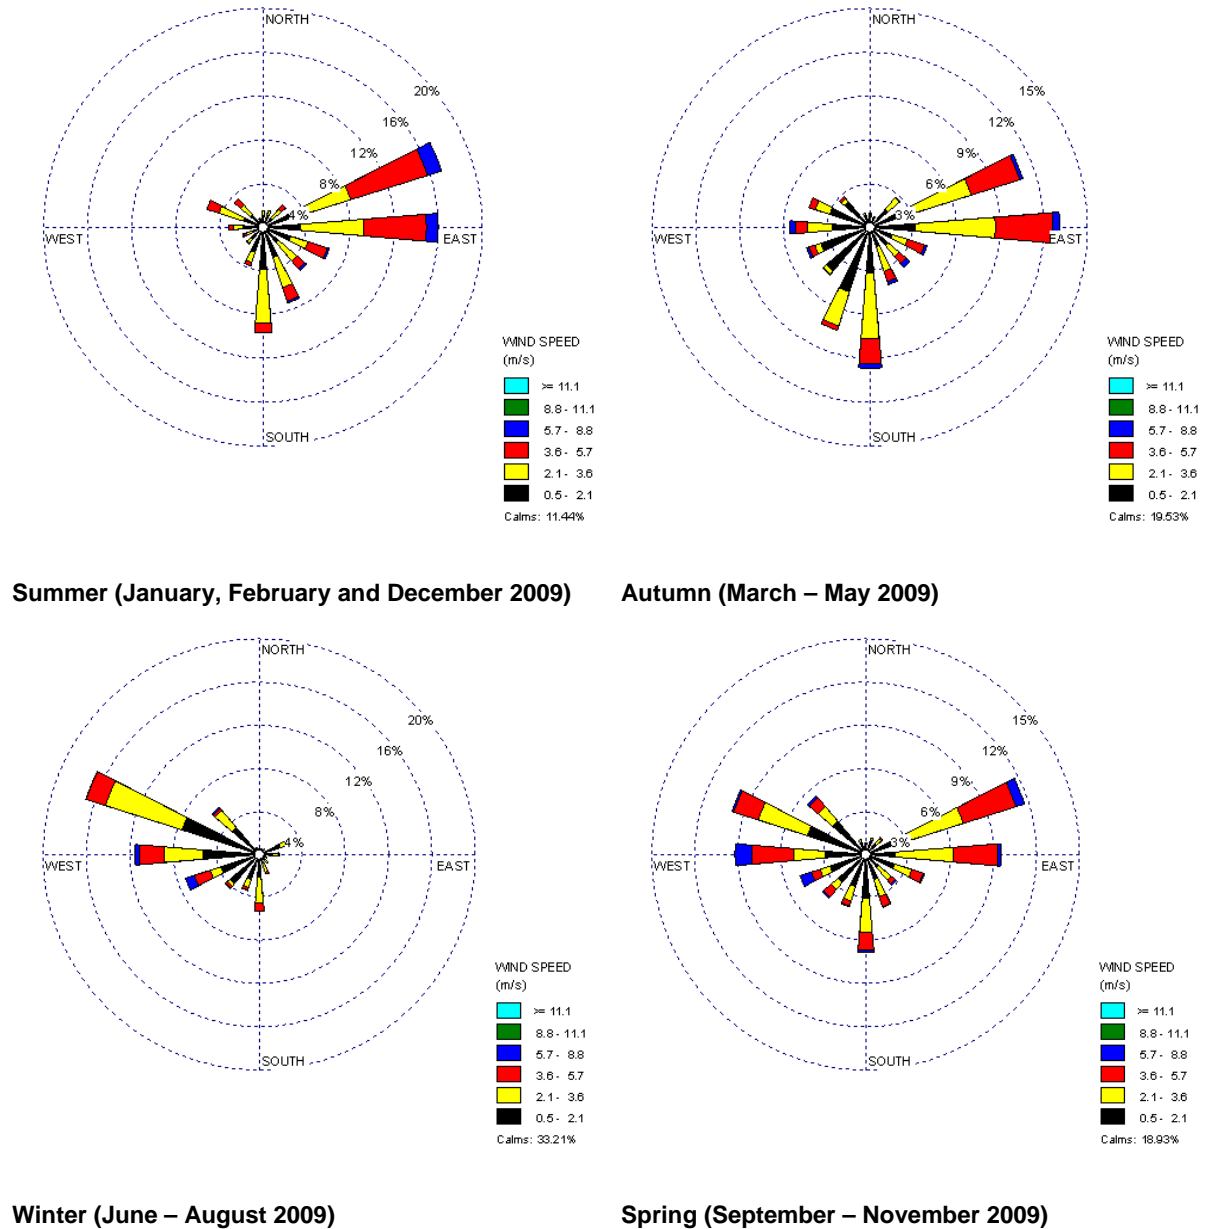
Figure 4-3 Bulga Coal Complex 2009 seasonal wind roses

Wind speed and wind direction data taken from Bulga Coal Complex's meteorological station in 2009 were used by Global Acoustics to create monthly and seasonal wind roses. Seasonal wind roses are provided in **Figure 4-3**. Wind direction was highly variable throughout the year and the prevailing wind direction varied according to the season. In summer the predominant wind direction was easterly, in autumn it was southerly, in winter it was westerly and in spring it was an east north easterly.

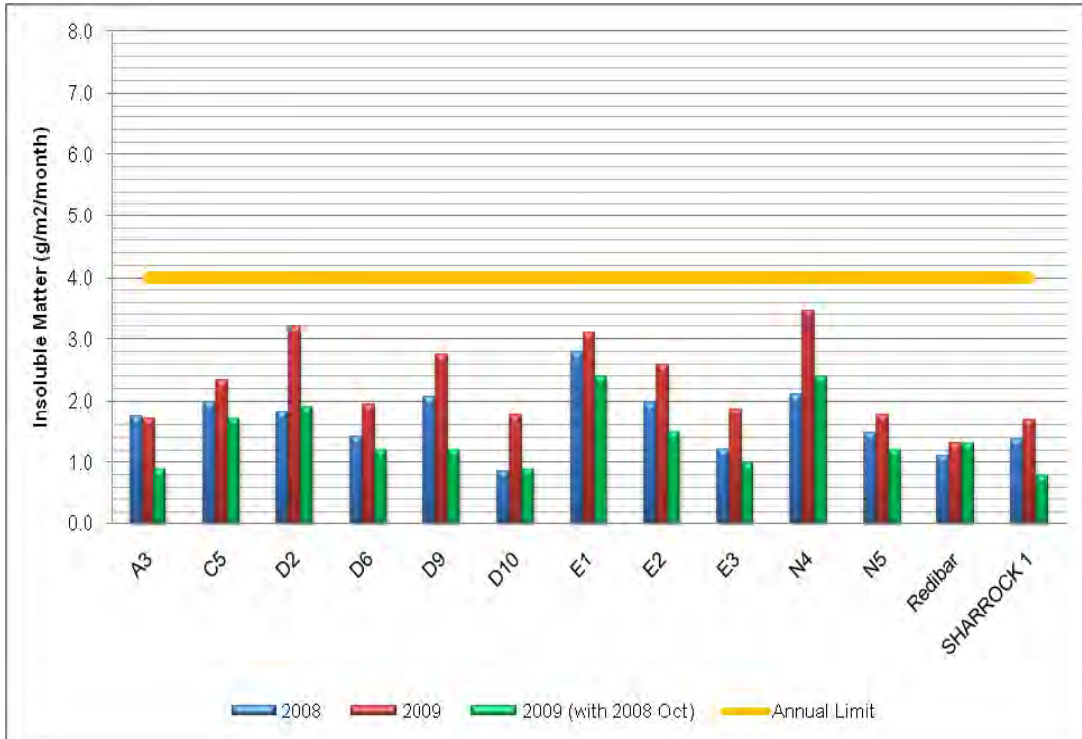
Figure 4-6b Comparison of off-site (sensitive receptor) dust deposition gauges 2008-2009

Results recorded at the dust deposition gauges representative of sensitive receivers (gauges located on privately owned property) are included in **Appendix I** and presented graphically in **Figure 4-6b**. The results of all sensitive receivers dust deposition gauges complied with the criterion.

The results of the eleven dust deposition gauges (B2, C1, C2, C3, C4, D3, D5, E1, N4, MTO D3 and MTO D9) that are located on mine owned land and close to active mining operations are presented in **Appendix I** and **Figure 4-6b**. Due to their proximity to active mining areas, these gauges are not representative of sensitive receptors and are used solely for modelling and comparative purposes. Therefore, the criteria presented in **Table 4-10** above should not be applied to the results from these gauges. However, it should be noted that with the exception of gauges C1, C2 and MTO D9, the dust deposition results during the reporting period remained below the 4 g/m²/month limit.

When compared with 2008 results, there was a general increase in the levels of deposited dust recorded during 2009 as shown on **Figures 4-6a** and **4-6b**. On further review it was identified that there was a very similar number of rain days in 2008 (100) and 2009 (104) and that the regional dust storm that impacted the majority of the east coast of Australia around the 23 September 2009 had significantly skewed the annual average results. In order to make a more relevant comparison of the 2008 and 2009 annual averages the 2009 October results (which included the dust from 23 September event) were replaced with the 2008 October results. The modified 2009 results (including 2008 October data) are also included in **Appendix I** and **Figures 4-6a** and **4-6b**. In general, the 2009 annual average (including the 2008 October data) was lower than the 2008 averages. This decrease is illustrated for both onsite and off-site gauges in **Figure 4-6a** and **Figure 4-6b** below.

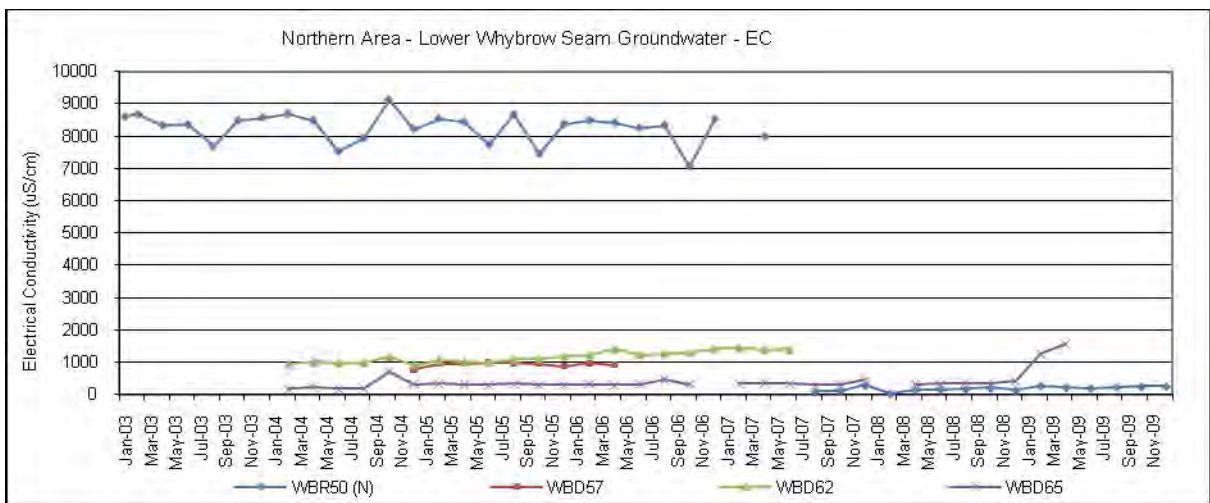
Figure 4-19 Northern area lower Whybrow Seam groundwater hydrographs

Figure 4-19 shows the groundwater monitoring results for the Northern area Lower Whybrow seam piezometers. Both WBD50(n) and WBD65 hydrographs show a marked response to Whybrow Seam depressurisation as is expected.

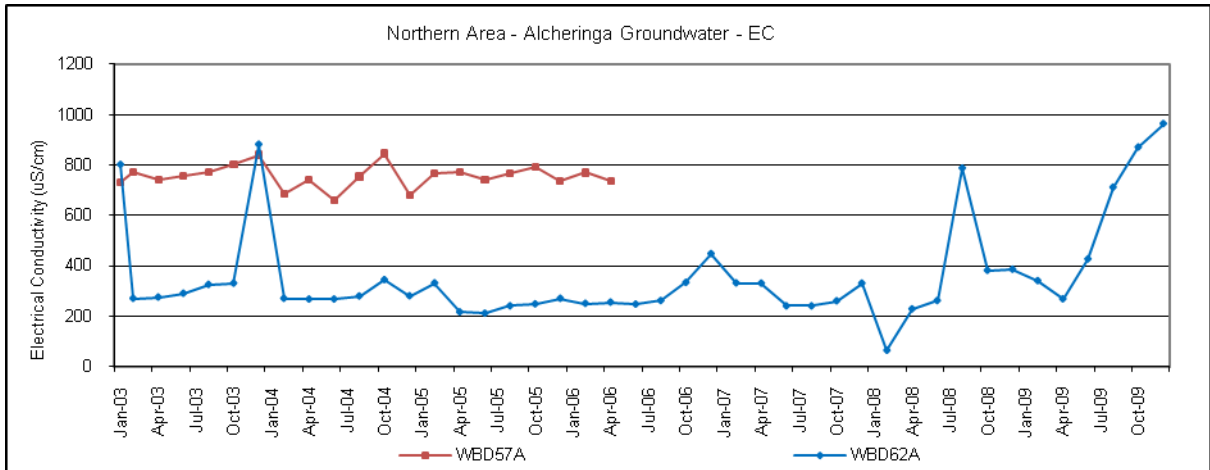
Figure 4-20 Northern area Alcheringa Seam groundwater hydrographs

Figure 4-20 shows the groundwater monitoring results for the Northern area Alcheringa seam bores with only one WBD62 remaining serviceable.

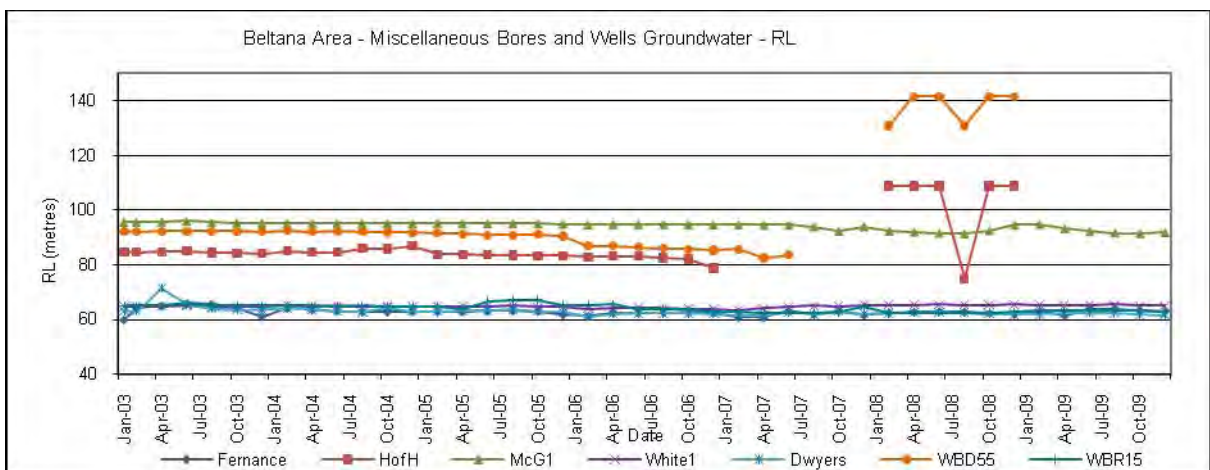
Figure 4-21 Beltana area miscellaneous bores and wells groundwater hydrographs

The groundwater monitoring results for other monitoring bores are shown in **Figure 4-21**. These mostly comprise shallow bores and wells that draw on the Wollombi Brook alluvial aquifer or a water bearing zone beneath the Fordwich Sill (most often the Alcheringa seam). All remaining piezometers show responses to the prevailing conditions. McG1 which is a hand dug well into the Fordwich Sill aquifer which appears to have sustained a gradual drop in water level over time with the December 09 water level being approximately 3.8 m below the Jan 03 water level. This McG1 hydrographic response is likely the result of regional depressurisation associated with Whybrow seam dewatering. The EC data shows a marked response to the June 07 recharge event and subsequent return to historic values. The pH data shows what is interpreted to be natural fluctuation.
